Debris/Ice/TPS Assessment and Integrated Photographic Analysis of Shuttle Mission STS-63

(NASA-TM-110649) DEBRIS/ICE/TPS
ASSESSMENT AND INTEGRATED
PHOTOGRAPHIC ANALYSIS OF SHUTTLE
MISSION STS-63 Final Report, 1 Feb.
- 13 Feb. 1995 (NASA. Kennedy
Space Center) 102 p

DEBRIS/ICE/TPS ASSESSMENT
AND
INTEGRATED PHOTOGRAPHIC ANALYSIS
OF
SHUTTLE MISSION STS-63

2 February 1995

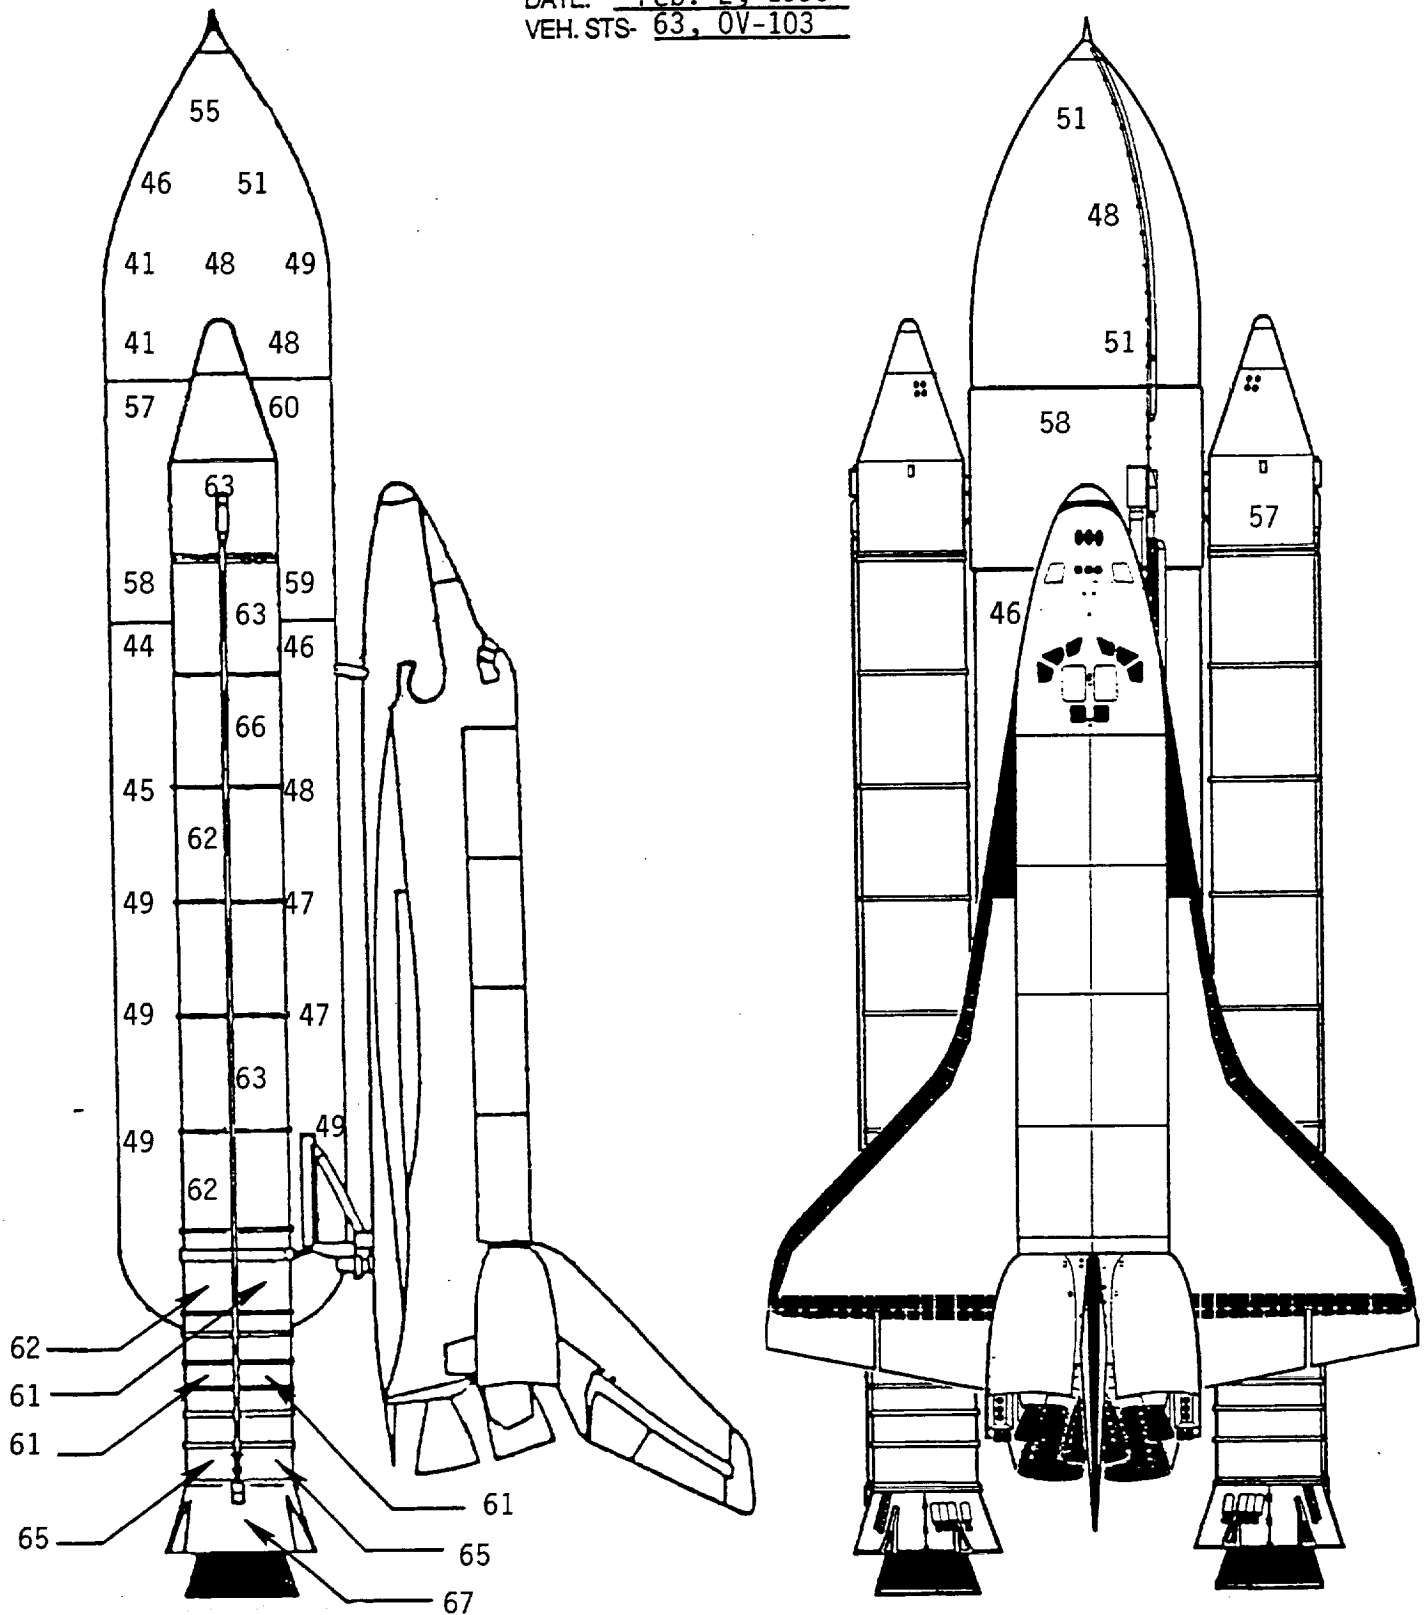
Figure 1 : Vehicle Surface Temperature STI Measurements

A portable Shuttle Thermal Imager (STI) infrared scanning radiometer was utilized to obtain vehicle surface temperature measurements for an overall thermal assessment of the vehicle, as shown in Figures 1 and 2.

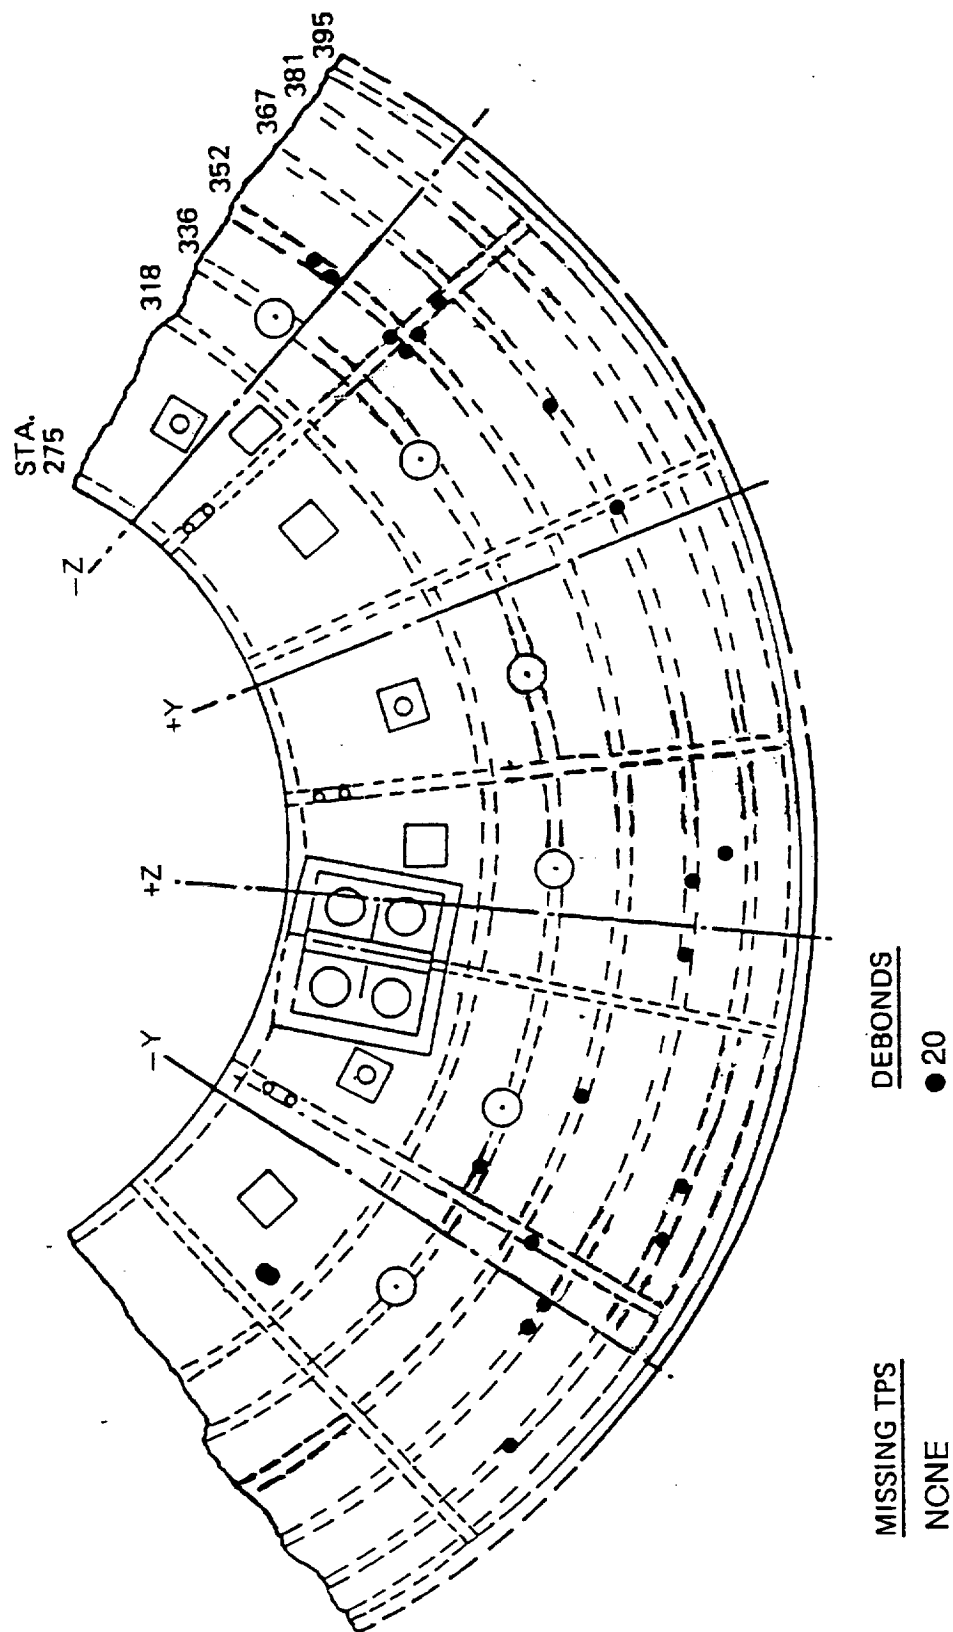
Figure 4 : RH SRB Frustum

The RH frustum was missing no TPS but had 19 debonds over fasteners and 1 debond over acreage (Figure 4). Hypalon paint was blistered/missing where BTA closeouts had been applied along the 395 ring frame and around the BSM's. Some of the underlying BTA was sooted. The BSM aero heat shield covers had locked in the fully opened position though all four cover attach rings had been deformed by parachute riser entanglement.

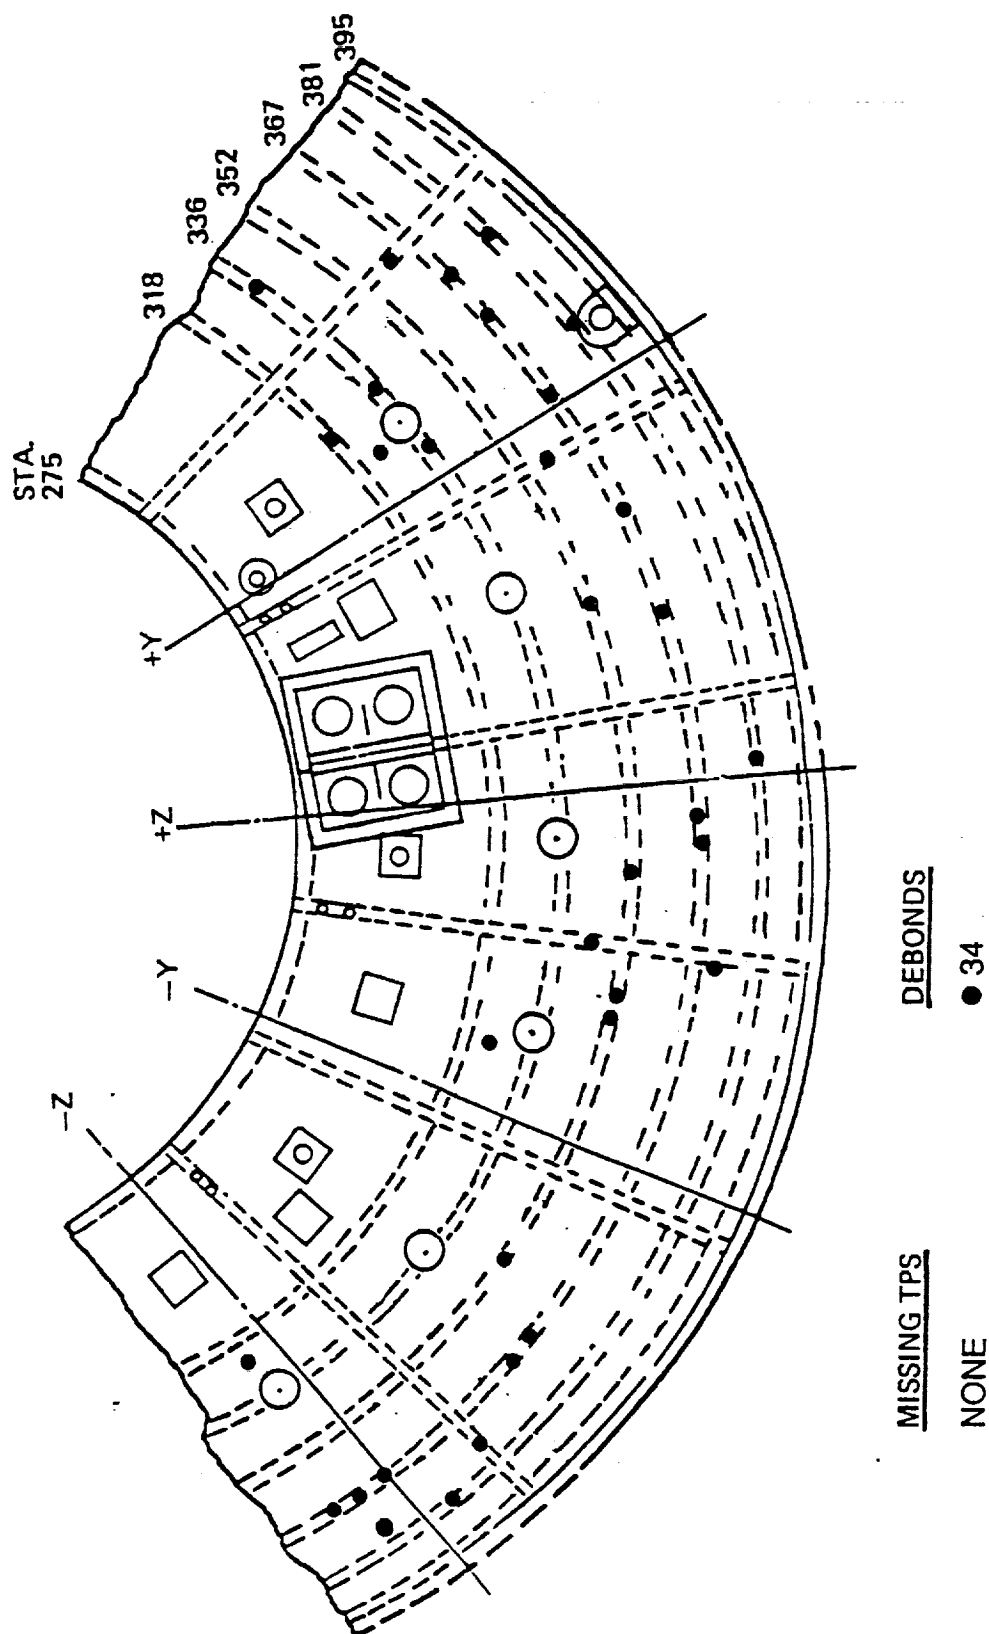
Figure 5 : LH SRB Frustum

The LH frustum was missing no TPS but had 34 MSA-2 debonds over fasteners (Figure 5). Hypalon paint was blistered/missing where BTA had been applied along the 395 ring frame and around the BSM's. Some of the underlying BTA was sooted. The BSM aero heat shield covers had locked in the fully opened position though two of the cover attach rings had been deformed by parachute riser entanglement.

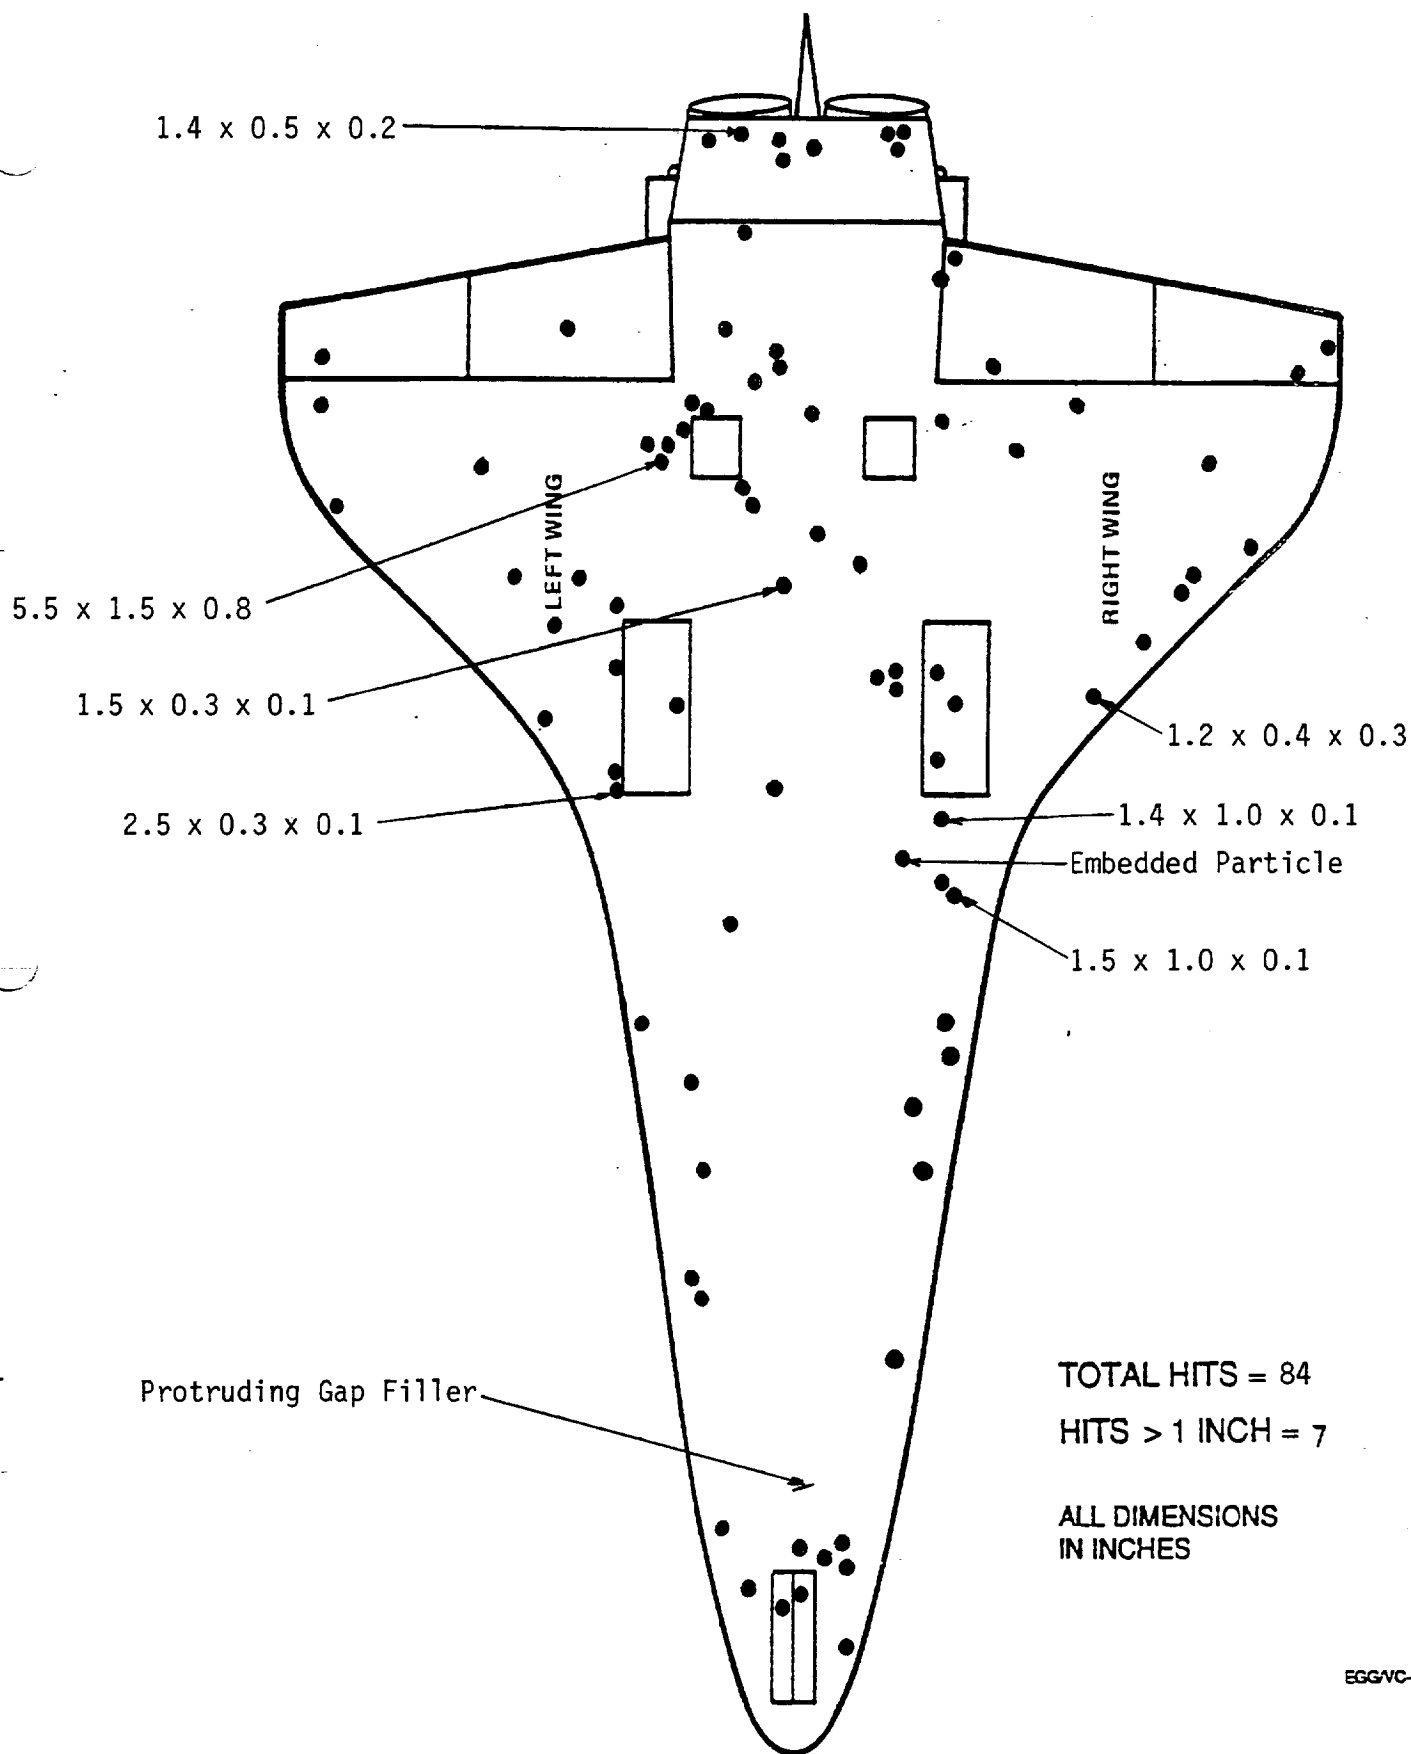
Figure 6 : Orbiter Lower Surface Debris Map

In summary, the total number of Orbiter TPS debris hits was average while the number of hits 1-inch or larger was less than average when compared to previous missions (Figures 10-11). The type of TPS damage was typical and not attributable to any single debris source.

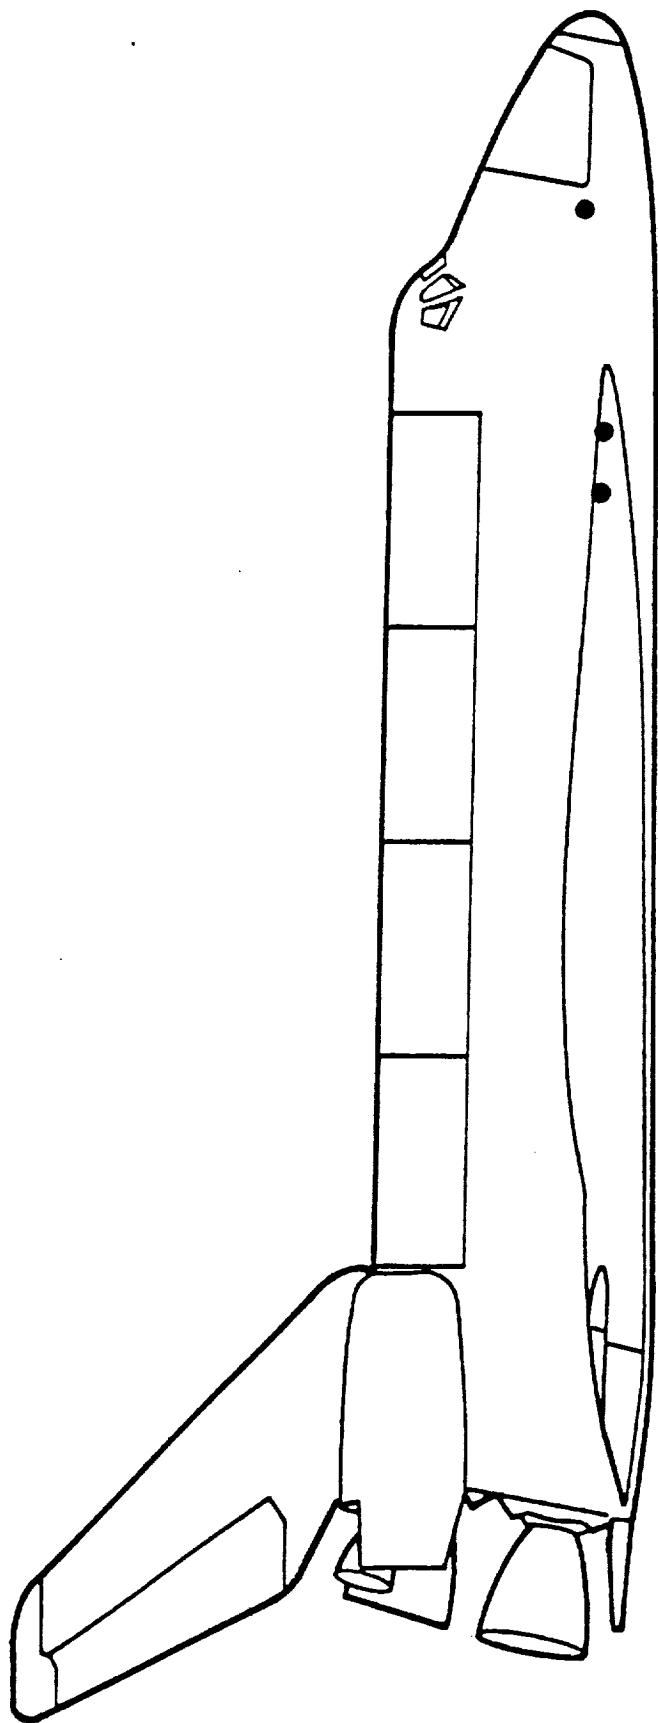
Figure 7 : Orbiter Right Side Debris Map

TOTAL HITS = 3
HITS \geq 1 INCH = 0

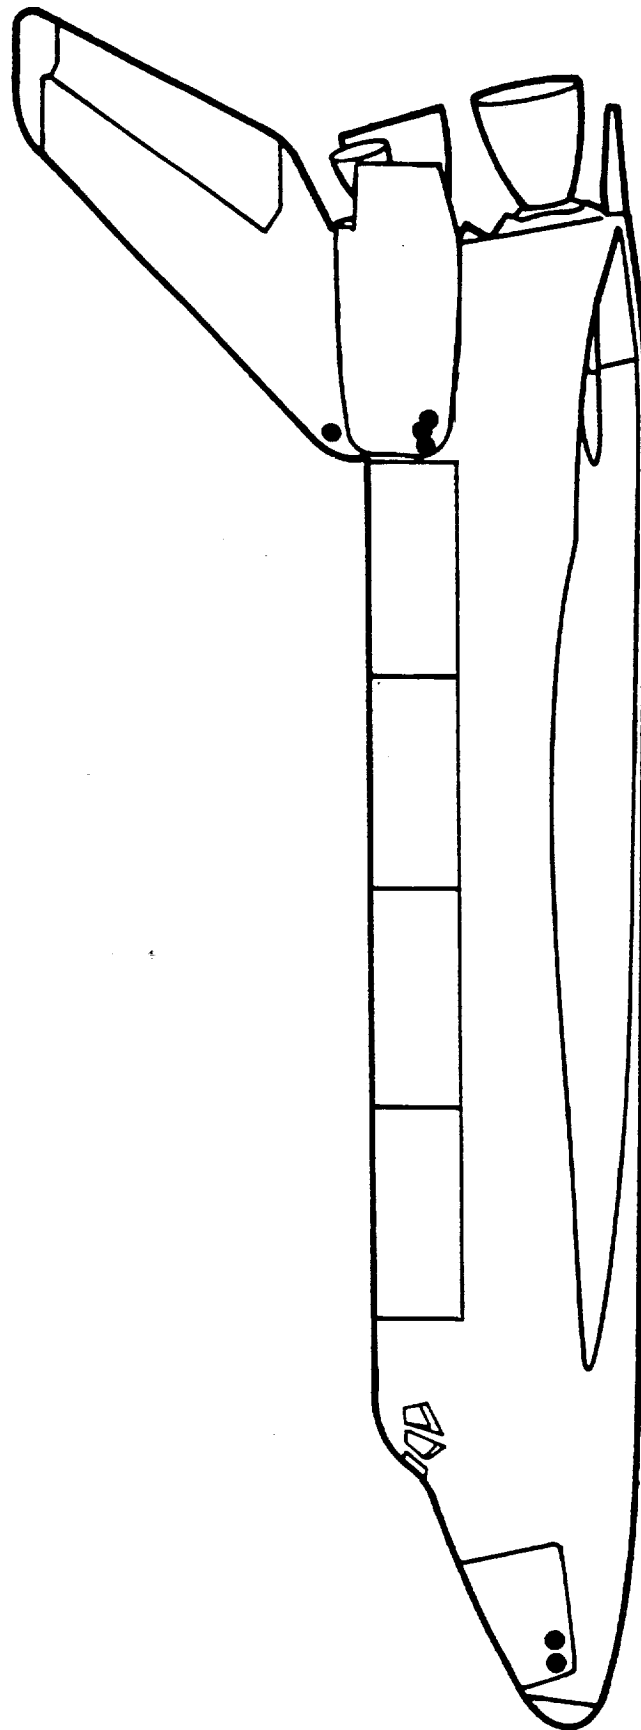
Figure 8 : Orbiter Left Side Debris Map

TOTAL HITS = 6
HITS \geq 1 INCH = 0

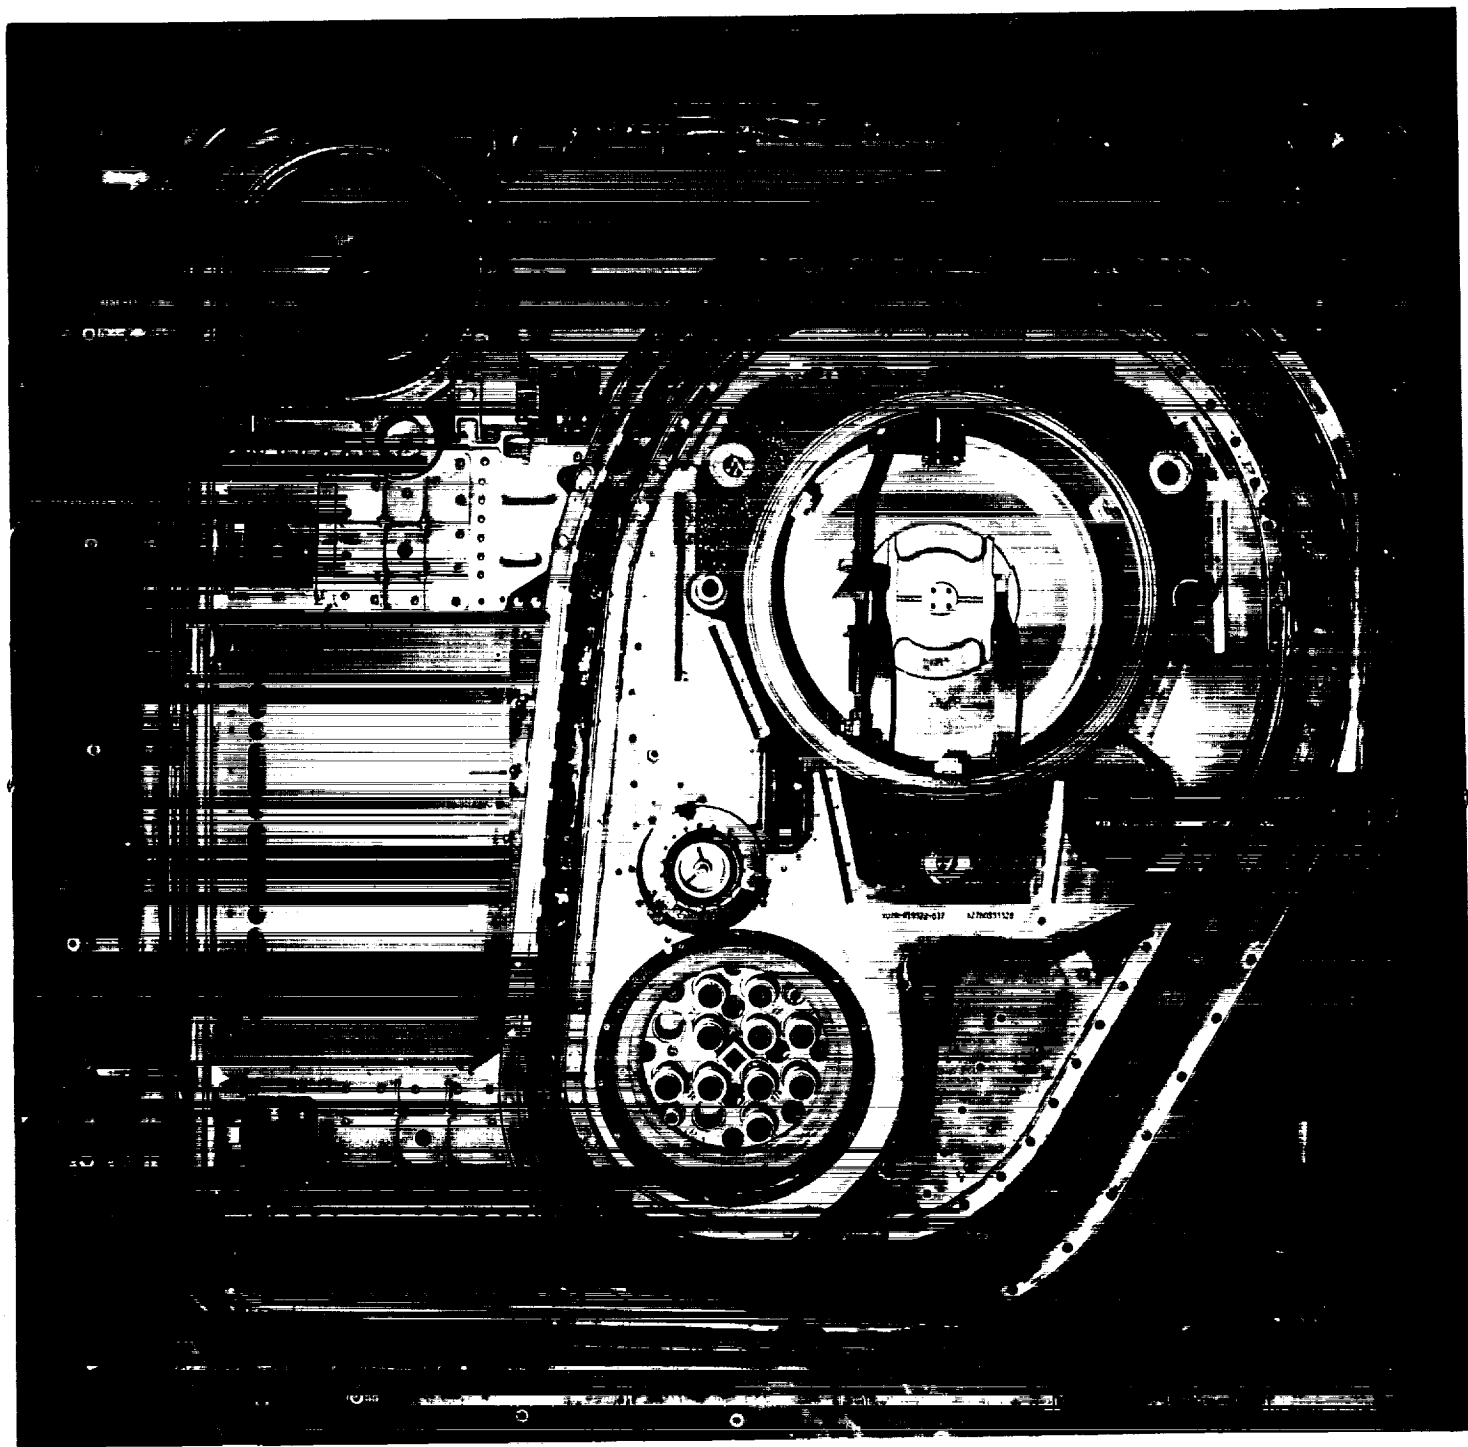
Photo 28 : LO2 ET/ORB Umbilical

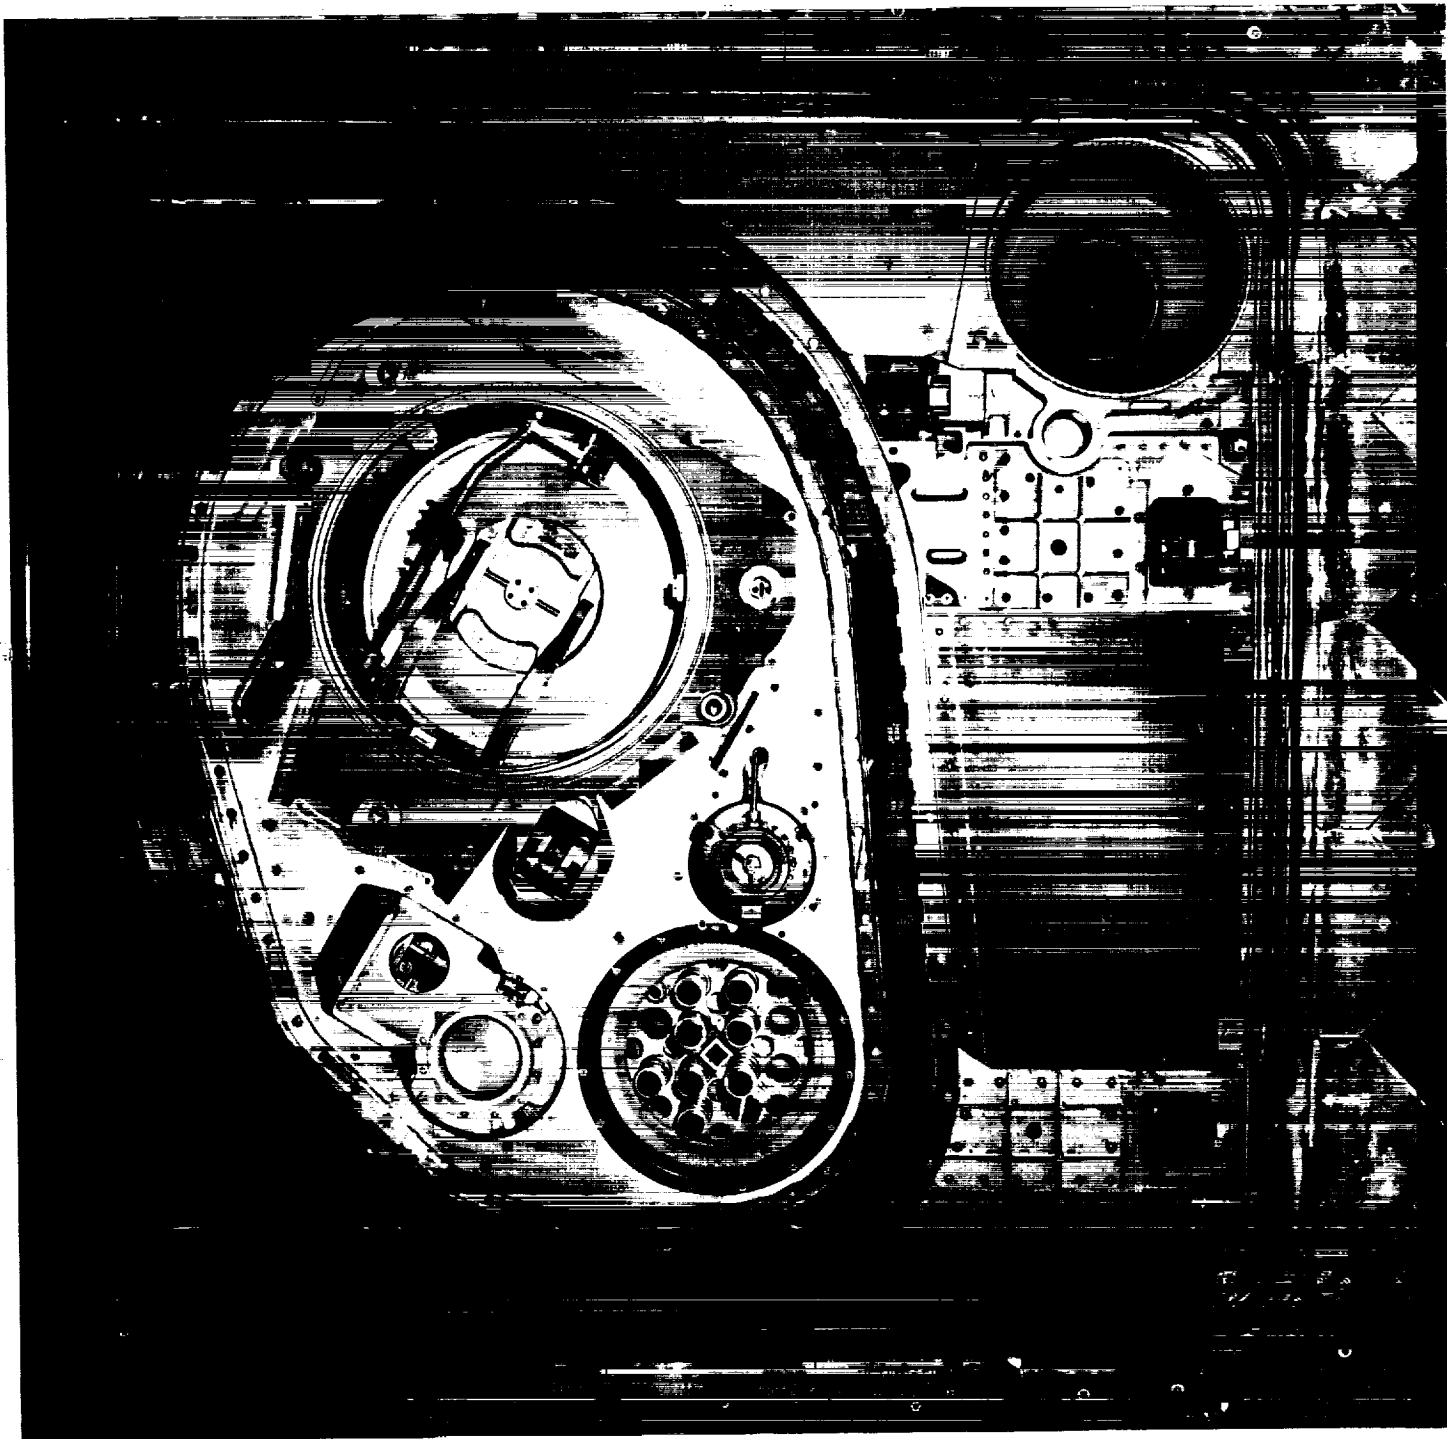
The largest tile damage site measured 5.5-inches by 1.5-inches by 0.75 inches deep and was located on the lower surface outboard of the LH2 ET/ORB umbilical directly aft of the LH MLG.

Photo 29 : LH2 ET/ORB Umbilical

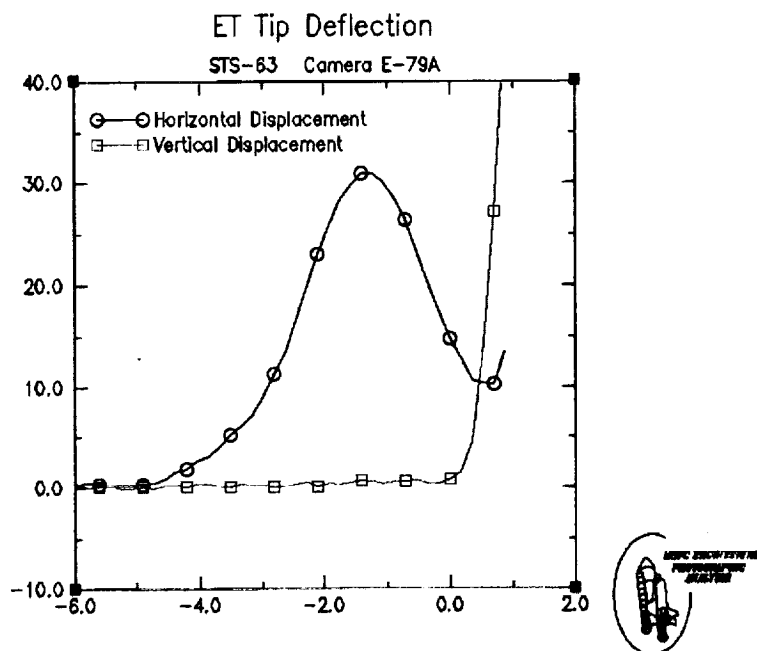
Figure 11 ET Tip Deflection

Maximum ET tip deflection for this mission was determined to be approximately 31 inches. Figure 11 is a data plot showing the measured motion of the ET tip in both the horizontal and vertical directions. A positive horizontal displacement represents motion in the -Z direction. These data were derived from film camera E-79A.
